## Report RW4-0

Sample report  
London (GB)  
Report number: RW4-0  
Date: June 12, 2017 00:00

Apartment

The apartment, overall, is of a reasonable standard however there are numerous snagging issues to address.

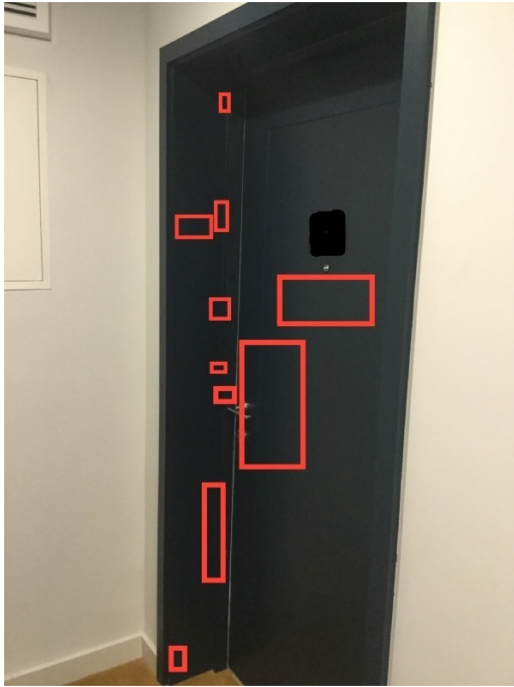
AREA	COMMENTS AND FINDINGS
HALL	
• FED and doorframe [0.1]	Handle loose and not level, various chips, indentations, scratches and stains Interior door frame gaps at base uneven (no caulking)

chips, scratches and stains

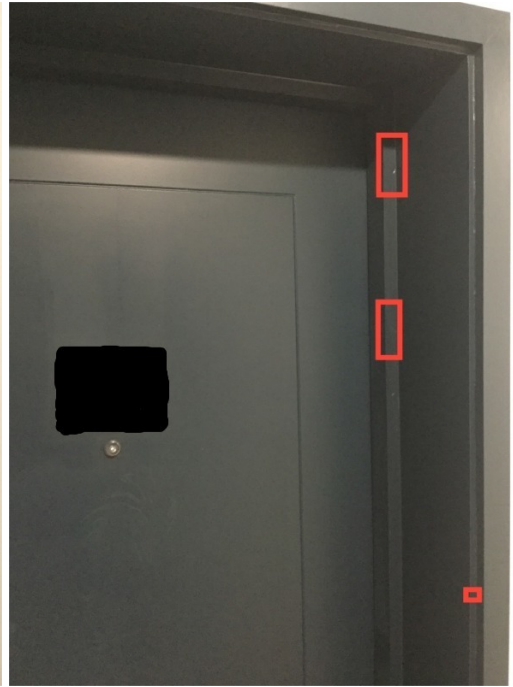
chips and indentations

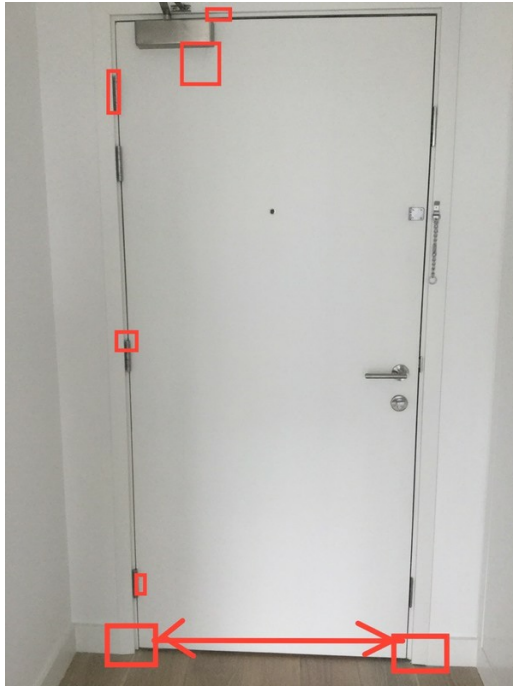
paint splashed on hinges, gaps uneven

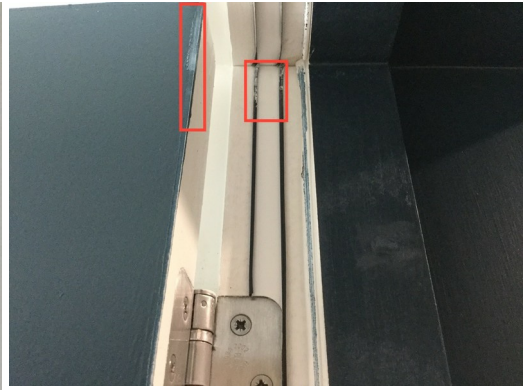
paint splashed

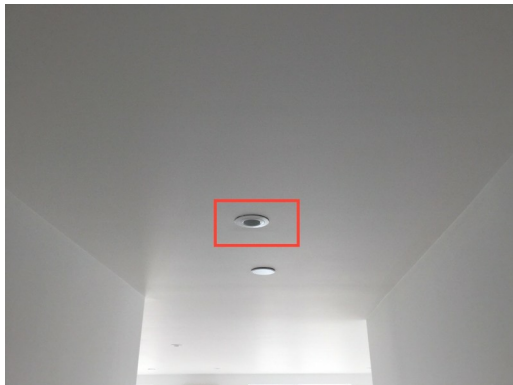
• Down-lighters [0.3]

Not flush with ceiling

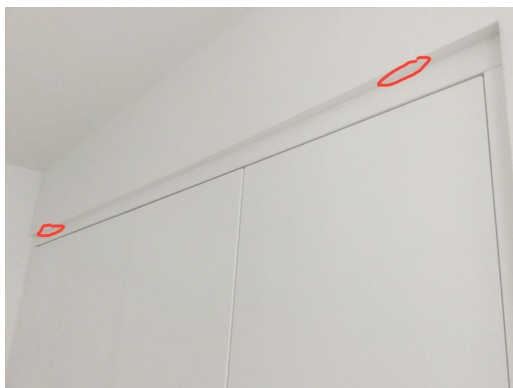
Rough finish, stained, marked, scratched and various blemishes

untidy finish

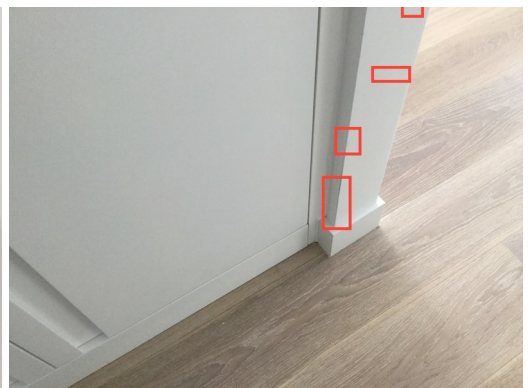
scratched, chipped, marked untidy finish

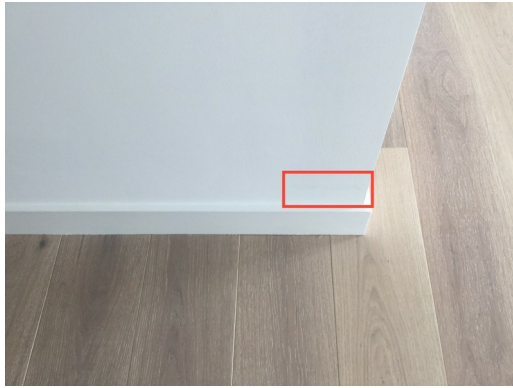
stained

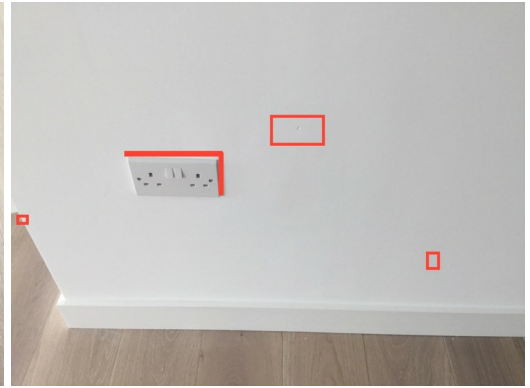
poor finish around sockets, indentation

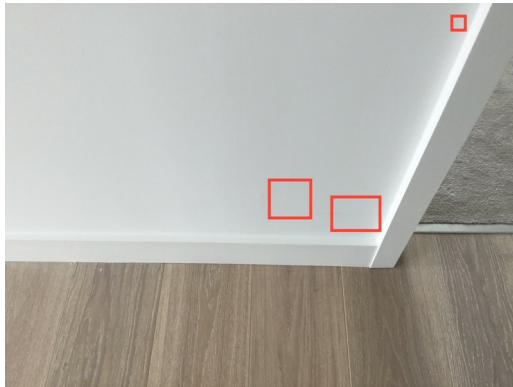
stained, blemishes

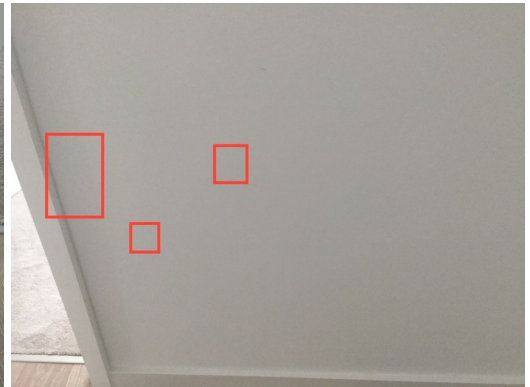
stained

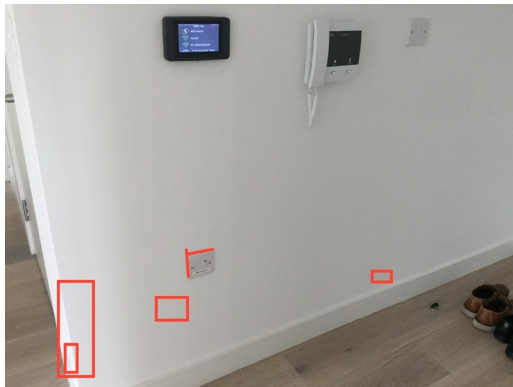
stained, chipped, untidy finish

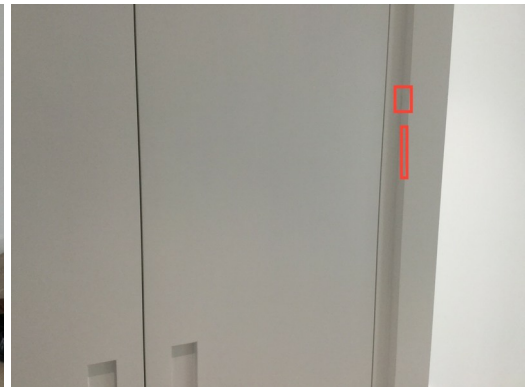
untidy finish

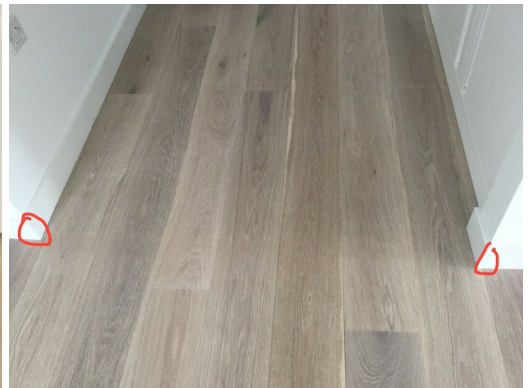
scratched, chipped

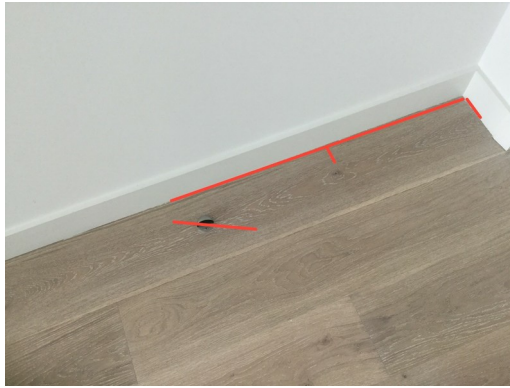
Scratches and various stains, boards creaking in front of Master bedroom

white in grain, pencil mark

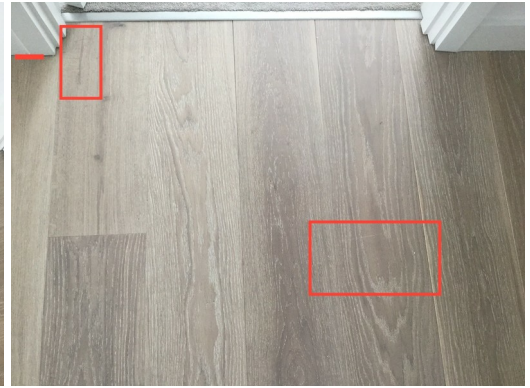
pencil marks and scratched, white in grain

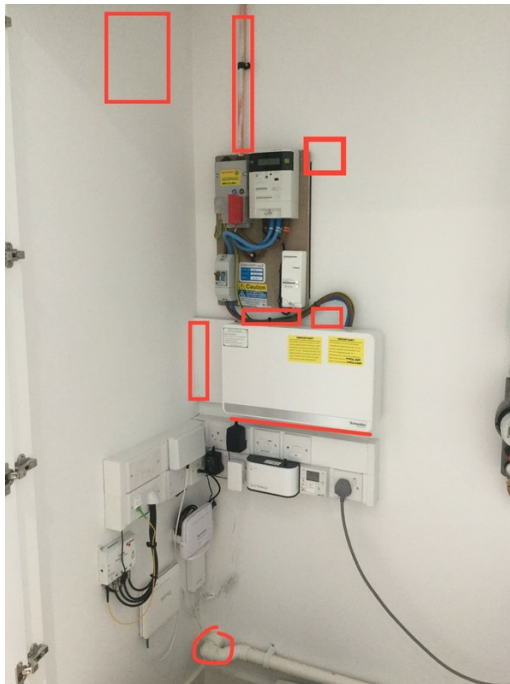
Stain top LHS, untidy finish around exit point of bottom LHS pipe.

Wiring, cables paint splashed

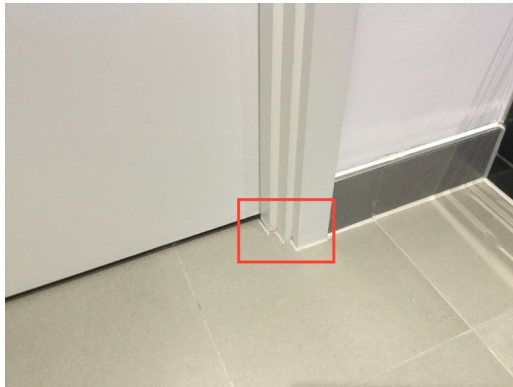
Door finish patchy, scratch top RHS of frame, shrinkage both sides of frame, interior- stain above handle, untidy mastic finish around base of frames, frame hinge side chipped at base

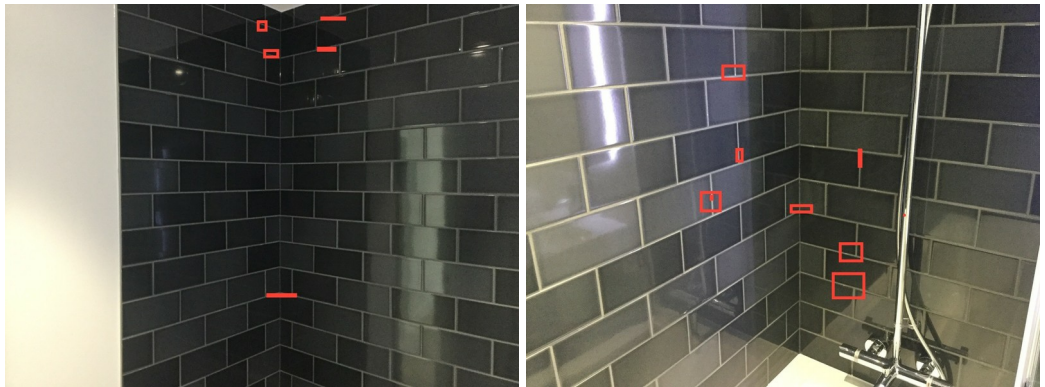
Various white marks in grout finish, untidy mastic finish RHS corner above up-tile

white marks

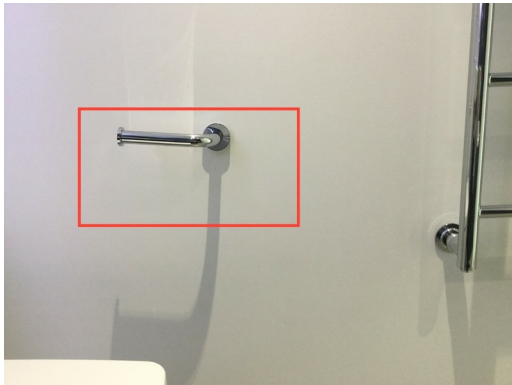
Loose, not level

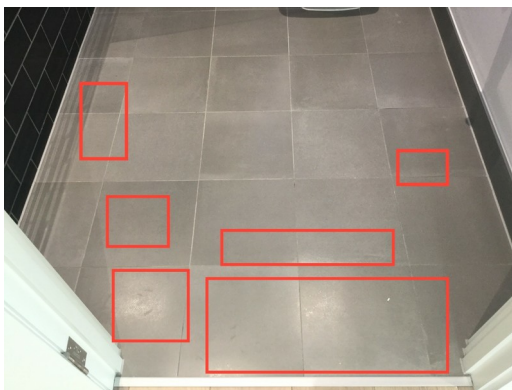
Various stains

grout finish patchy

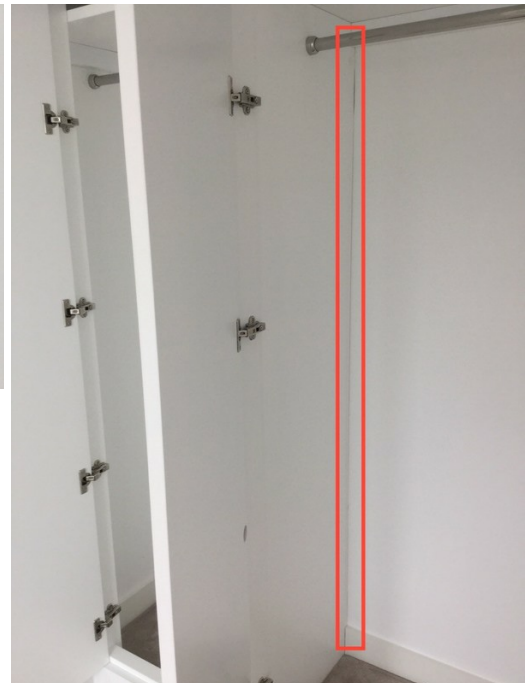
gaps

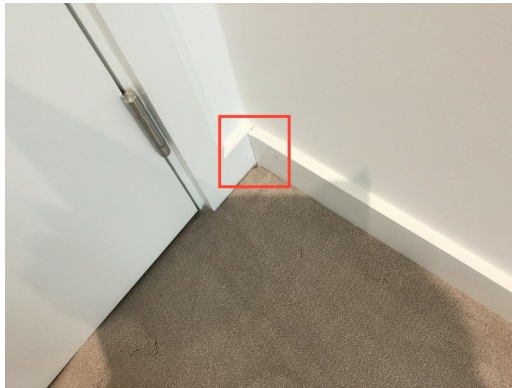
shrinkage

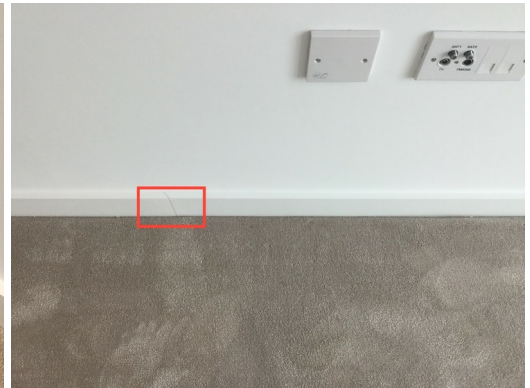
Joint visible

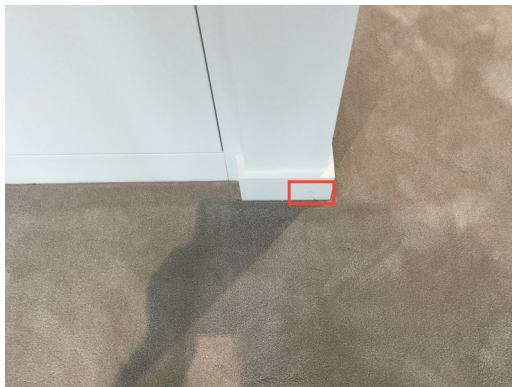
stained

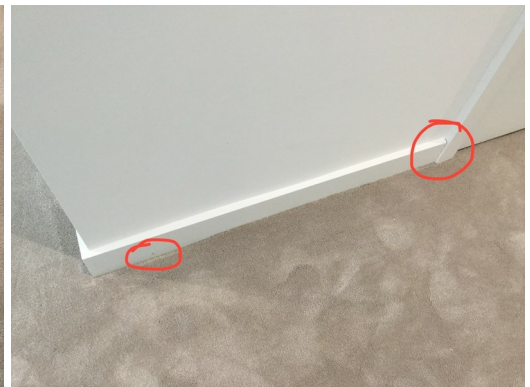
hole, gap

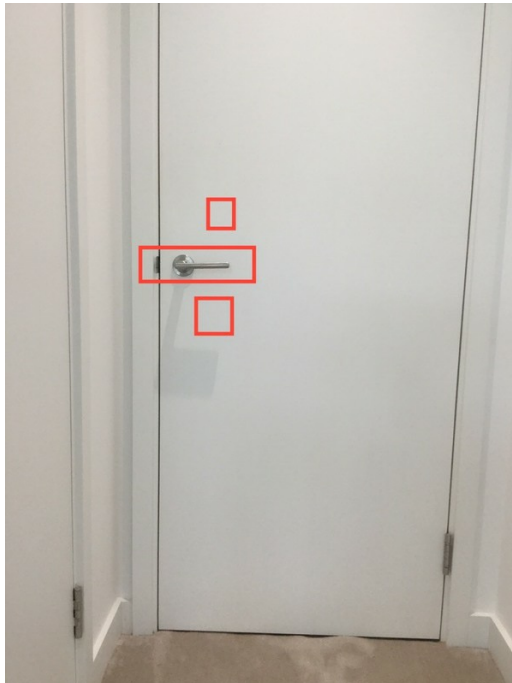
Handle not level, door marked around handle

handle not level, marked

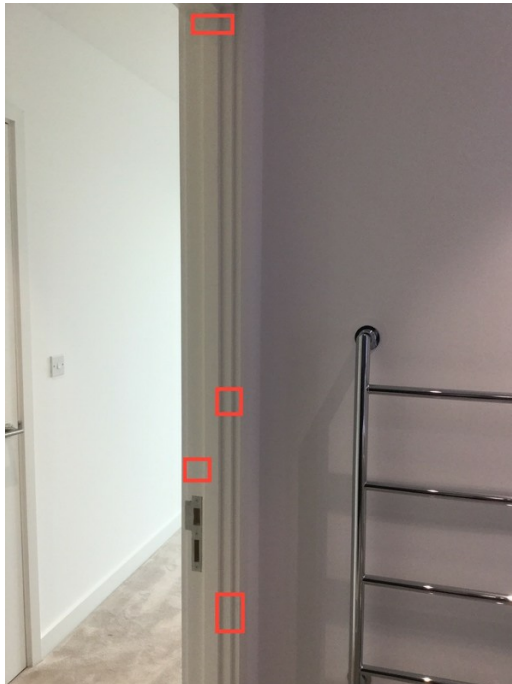
Stained left of handle, shrinkage along LHS frame, interior - blemish above keep, marked below keep

indentations, marked

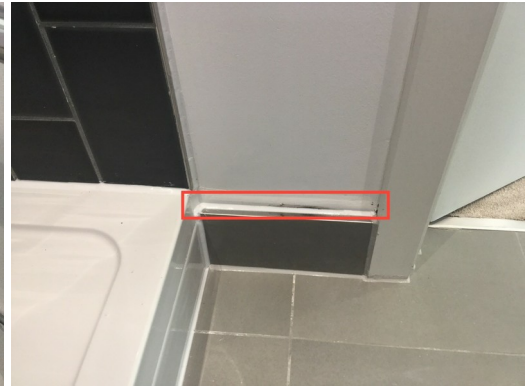
untidy finish

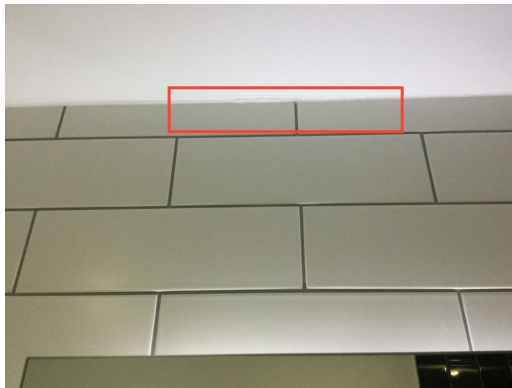
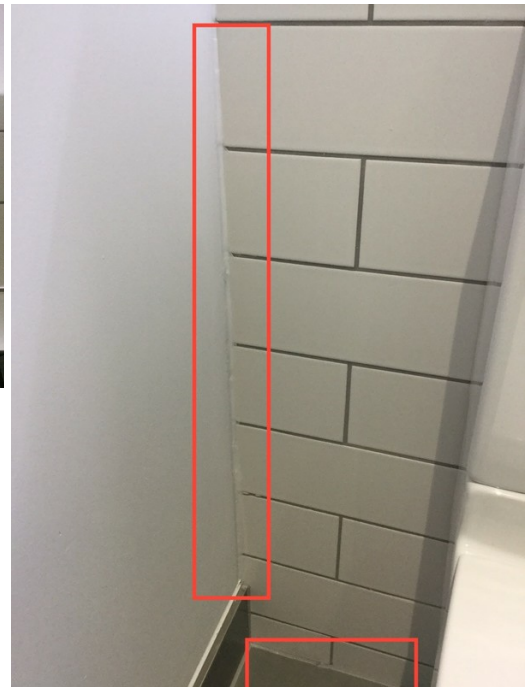
Untidy mastic finish.

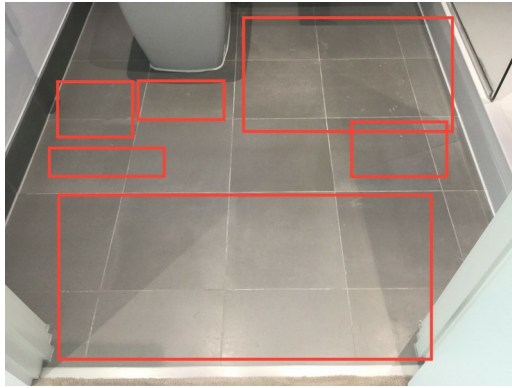
various stains, patchy grout finish

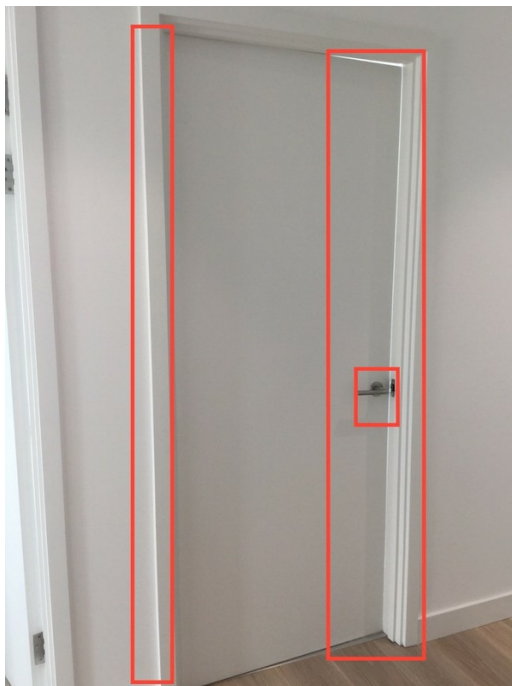
Door/frame not square (unable to close)

door/frame not square

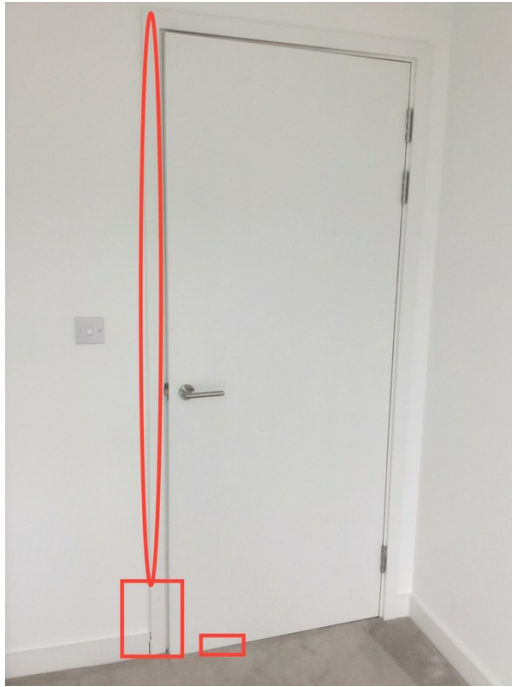
shrinkage, poor finish, marked

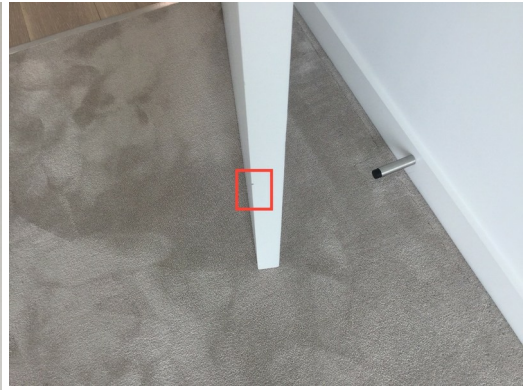
chipped

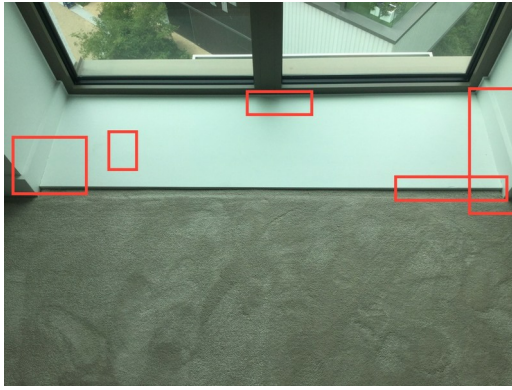
shrinkage, stains, chipped

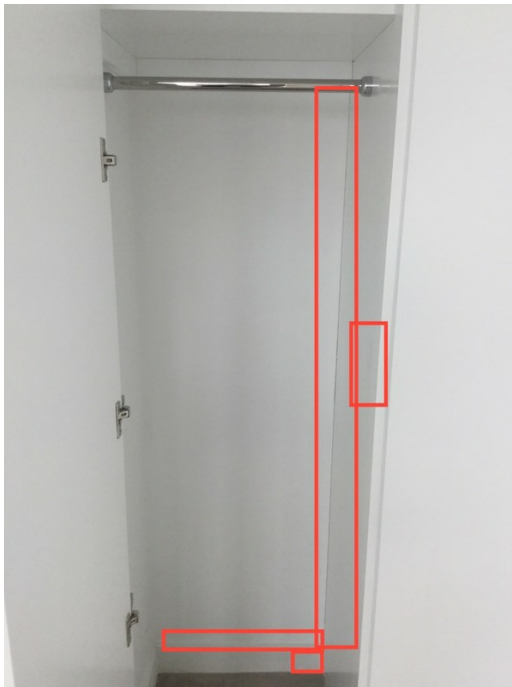
stained around LHS rail

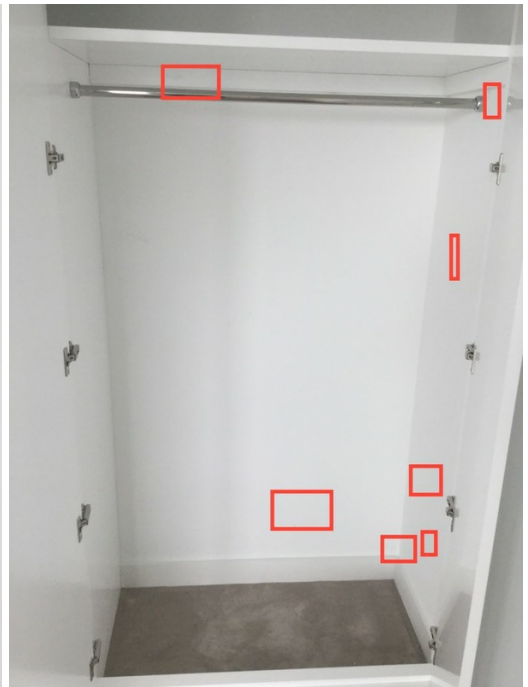
hole next to RHS pole, various stains and blemishes

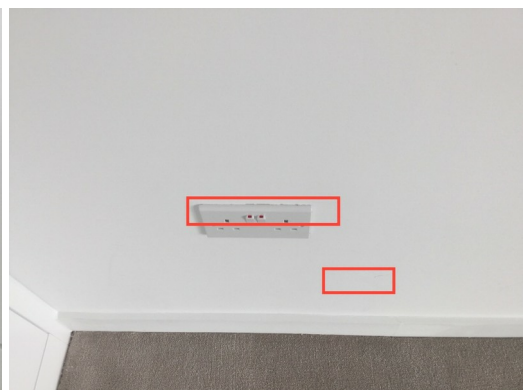
gap and marked

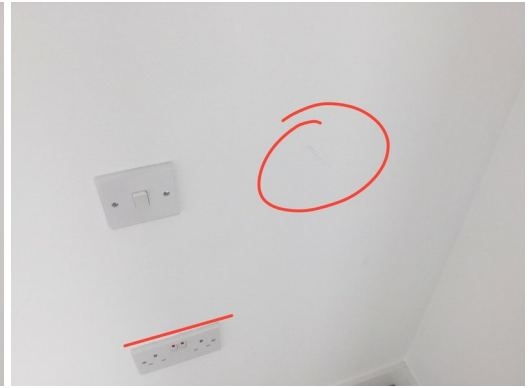
untidy finish, scratched

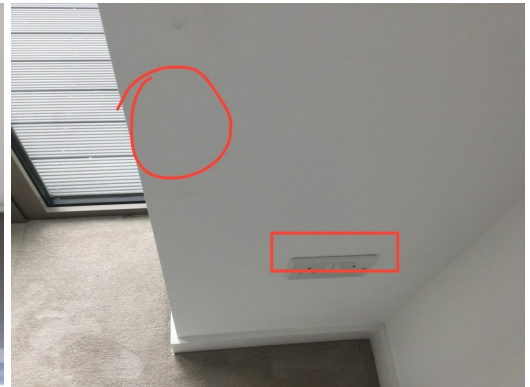
stained, gap

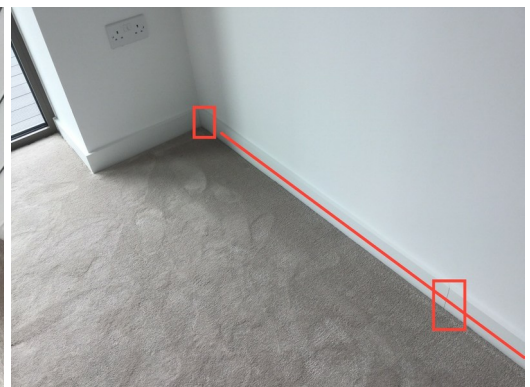
joint visible, scratched

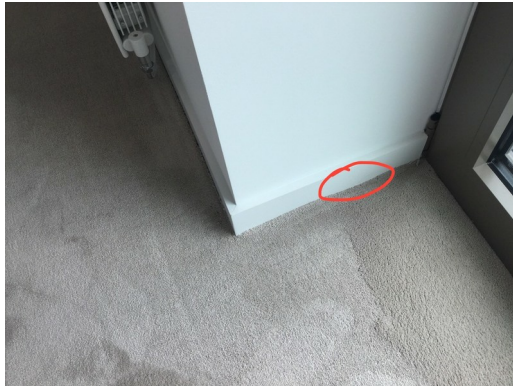
stained

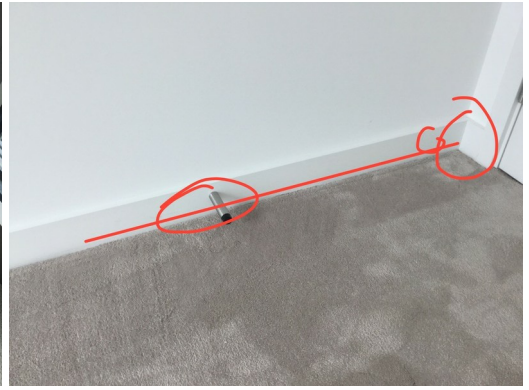
scratched

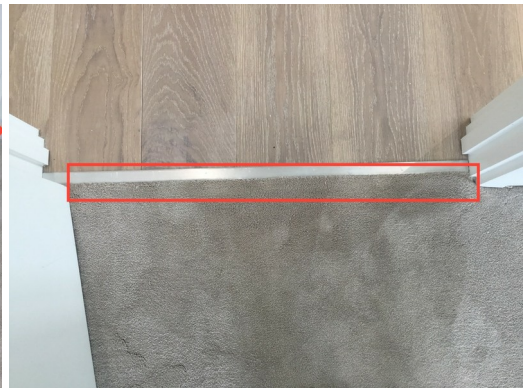
Poorly fitted and trimmed

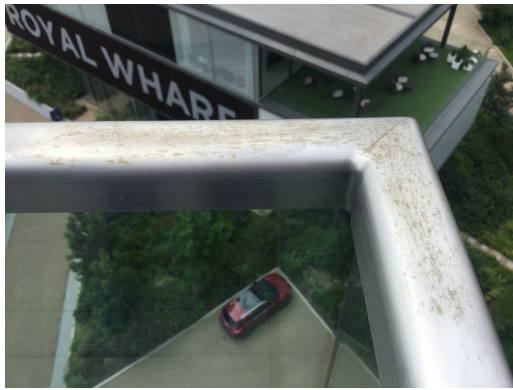
Rusted on both far corners, movement in LHS balustrade rail.

rusty both sides

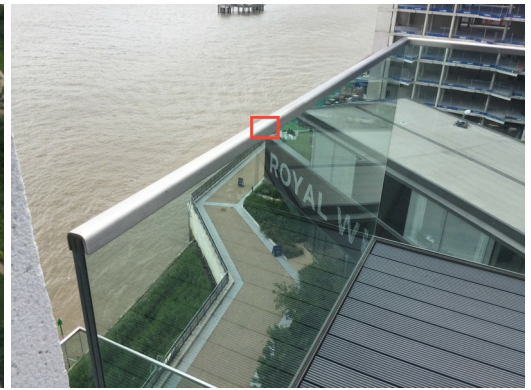
Hand rail - movement

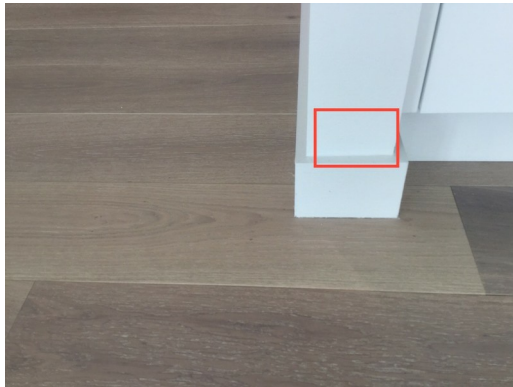
stained

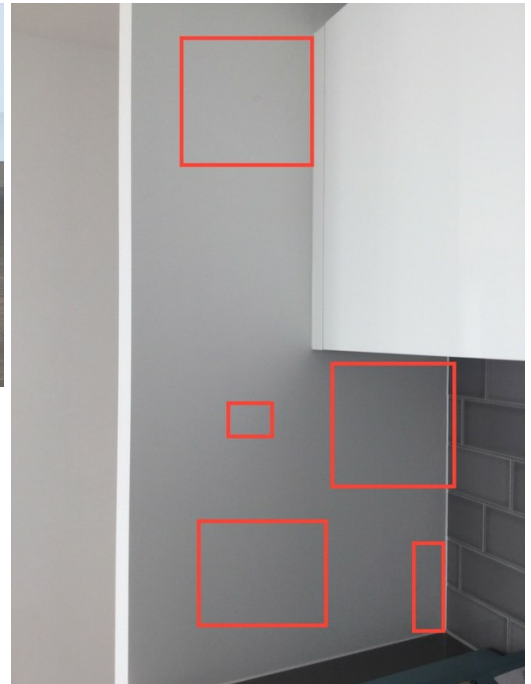
Stained, rough finish

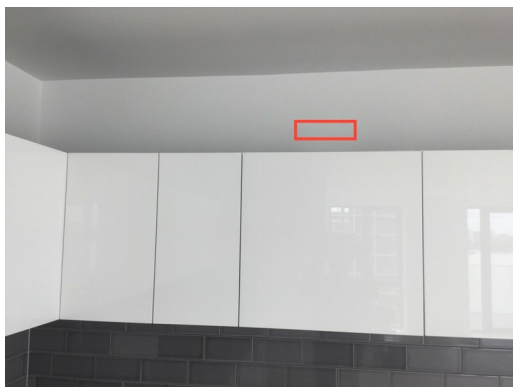
stained

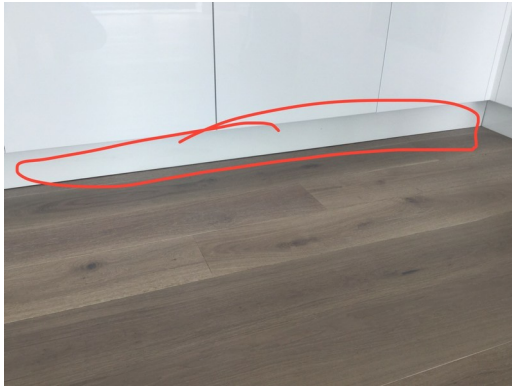
stained

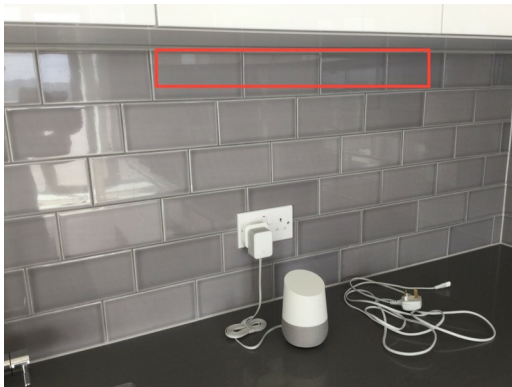
stained

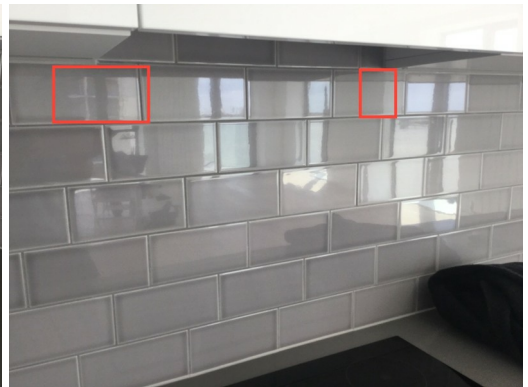
stained

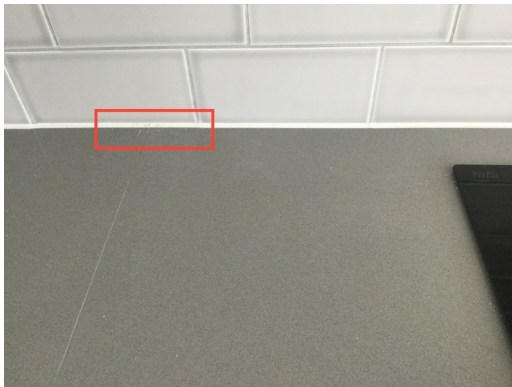
untidy, uneven finish

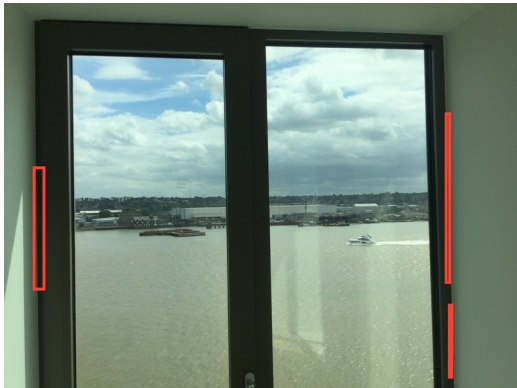
<ul style="list-style-type: none"> <li>• <b>Windows</b> [0.72]</li> </ul>	Mastics stained Shrinkage RHS

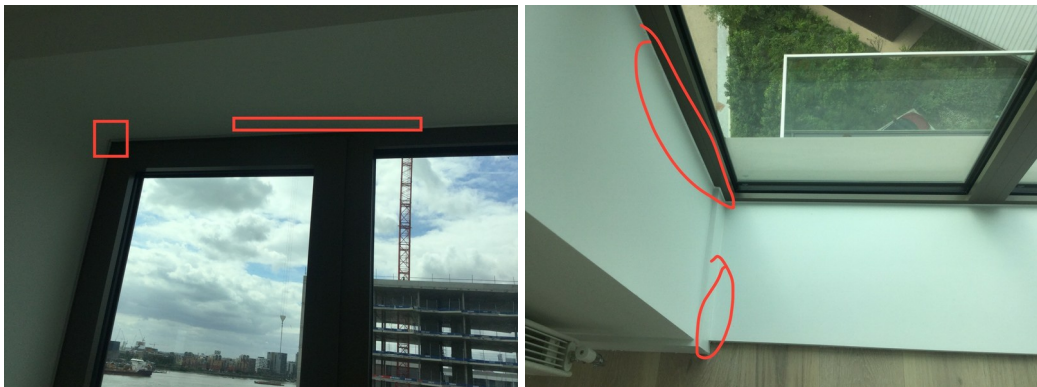
<p>untidy, uneven plaster finish surrounding frame</p> <p>shrinkage LHS of sill, mastic stained, untidy finish</p>
<ul style="list-style-type: none"> <li>• <b>Window sills</b> [0.74]</li> </ul>	Shrinkage

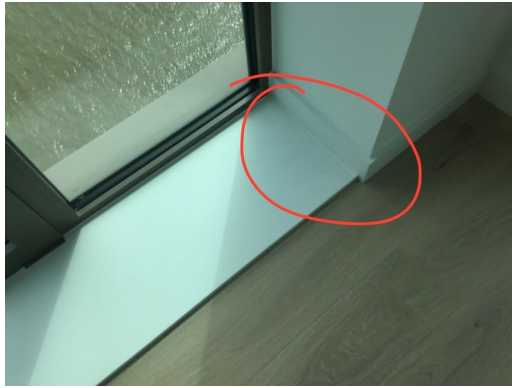
shrinkage

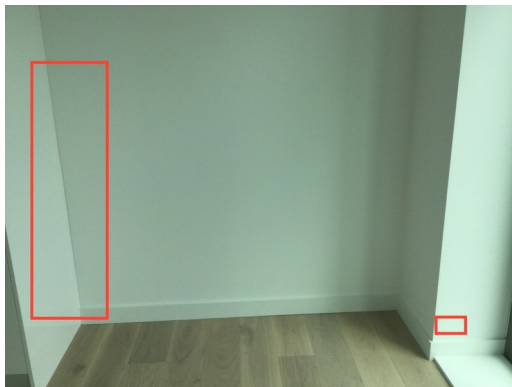
patchy finish

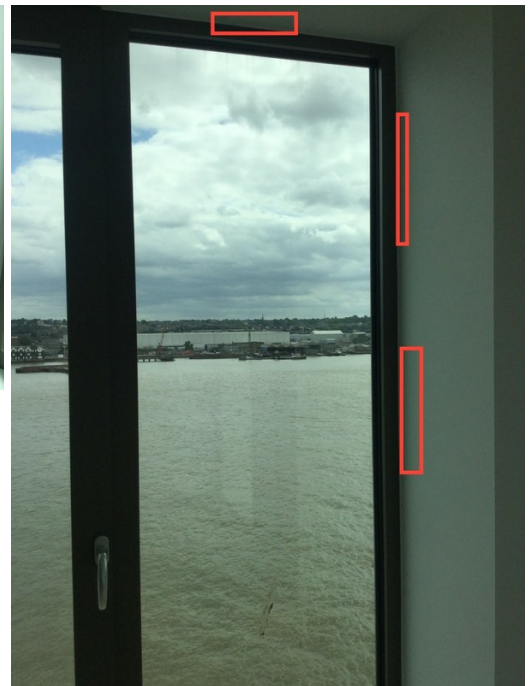
uneven finish, mastic untidy finish

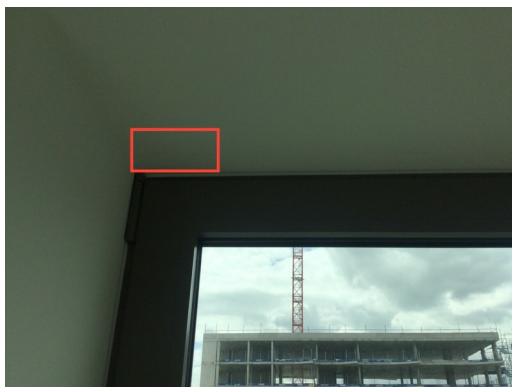
stained

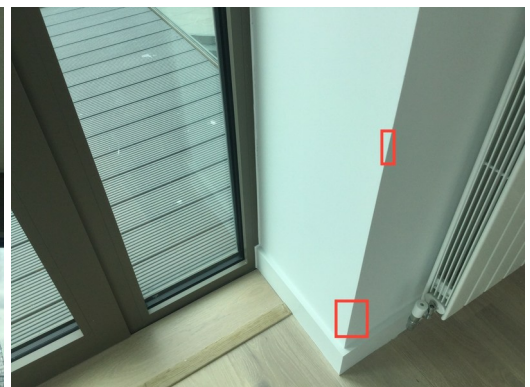
chipped, indentation

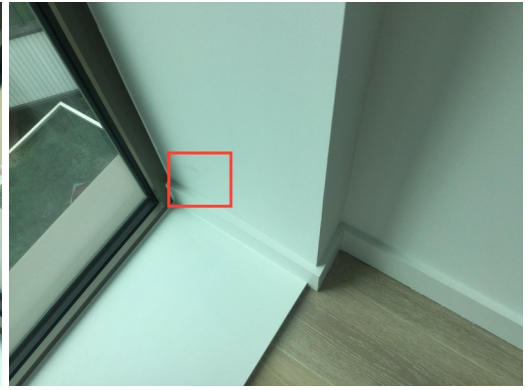
stained

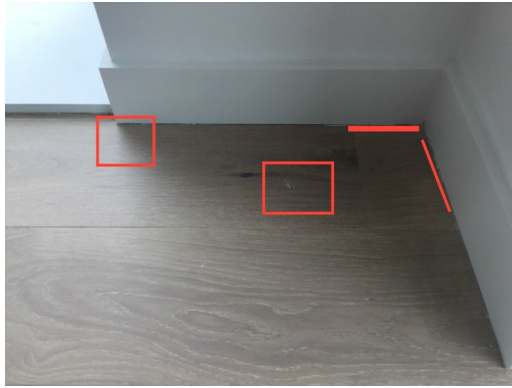
White in grain

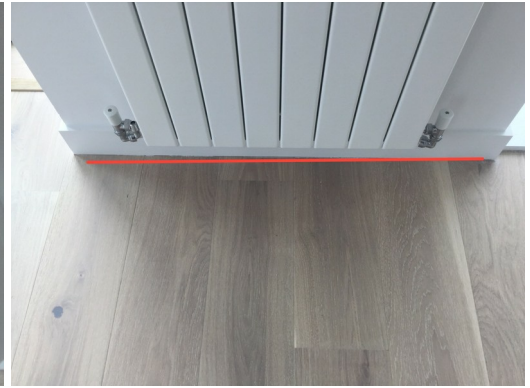
white in grain

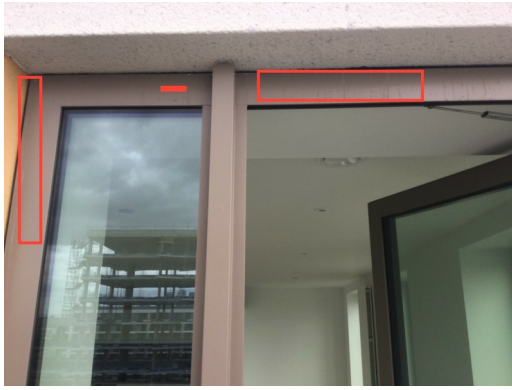
Exterior water stained

Water stained

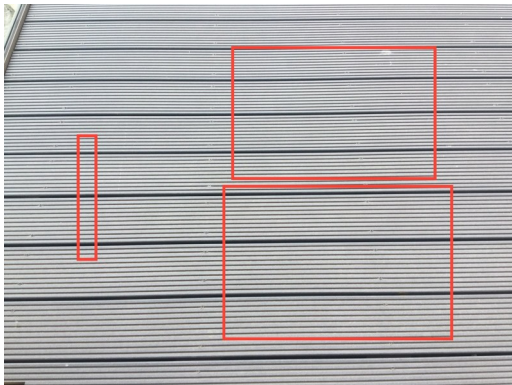
Boards creak, stained, scratched

scratched, boards creak
