## Report RW4-0

Sample report  
London (GB)  
Report number: RW4-0  
Date: June 12, 2017 00:00

Apartment

The apartment, overall, is of a reasonable standard however there are numerous snagging issues to address.

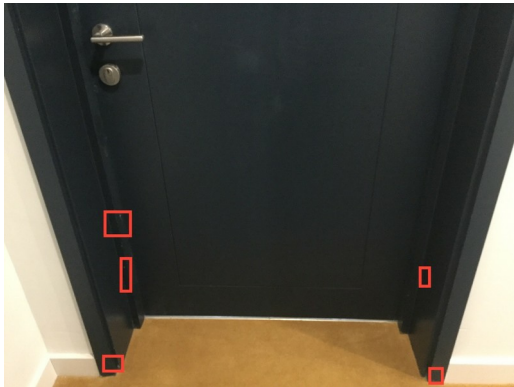
chips, indentations

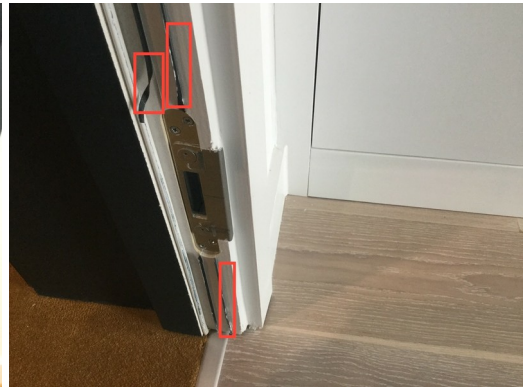
paint splashed on strips both side, strip cut short of bottom and top hinge

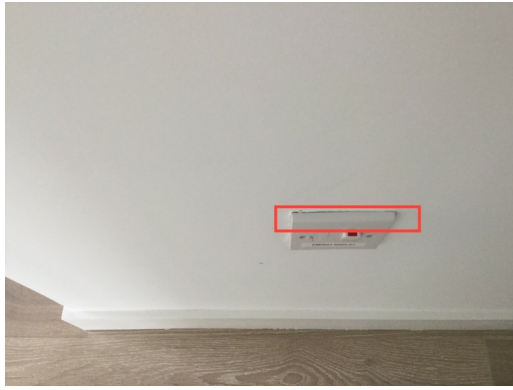
• Energy display [0.6]

Not flush with wall

not flush with wall

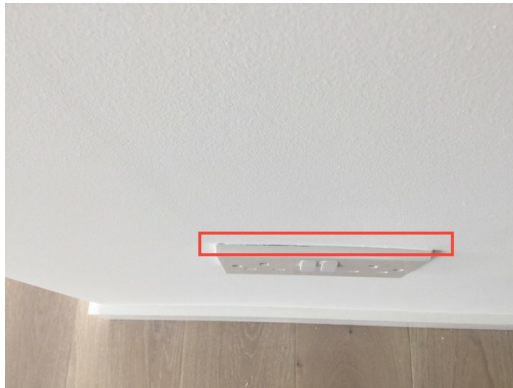
• Light switches and sockets [0.7]

Gaps around most sockets and switches

gap, wall finish uneven?

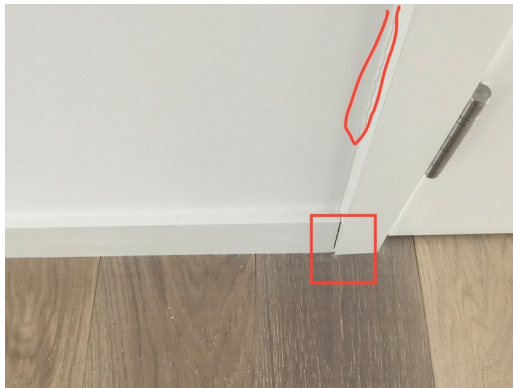
• Skirting boards [0.8]

Gaps/ shrinkage.

gap left of bathroom and left of bedroom 2

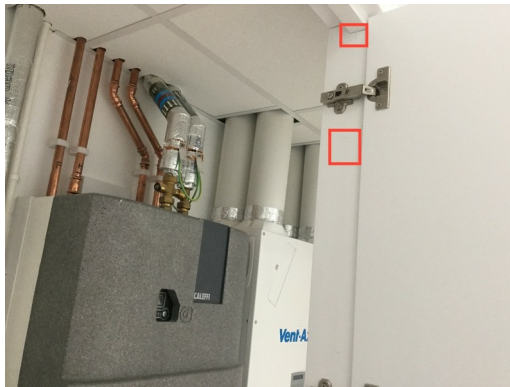
### • R/h door [0.10]

Blemish, untidy finish

Untidy finish, blemish

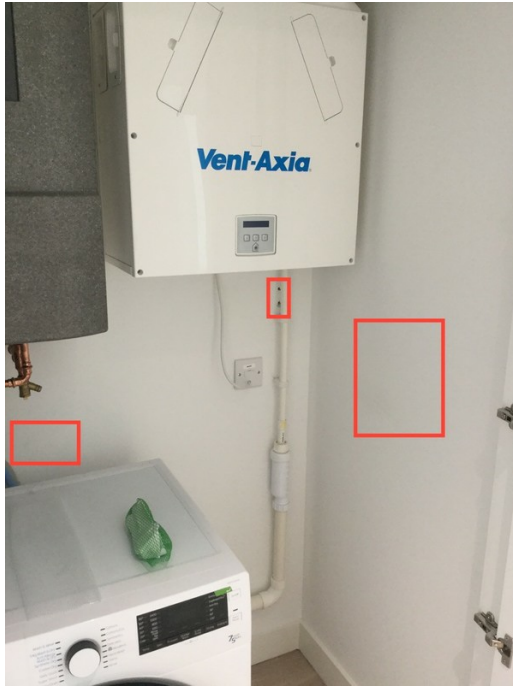
<ul style="list-style-type: none"> <li>• <b>Cable conduits</b> [0.12]</li> </ul>	<p>Paint splashed along LHS edge and uneven gap</p> <div data-bbox="413 197 930 580" data-label="Image"> </div> <p>uneven finish, gap, paint splashed</p>
<ul style="list-style-type: none"> <li>• <b>Skirting</b> [0.13]</li> </ul>	<p>Shrinkage/gap in joint LHS corner</p>
<p>UTILITY</p>	
<ul style="list-style-type: none"> <li>• <b>R/h door</b> [0.14]</li> </ul>	<p>Doors not flush, gaps in between doors irregular.</p> <div data-bbox="413 860 930 1243" data-label="Image"> </div> <p>doors not flush</p>
<ul style="list-style-type: none"> <li>• <b>Emulsioned walls</b> [0.15]</li> </ul>	<p>Two holes above MVHR (behind pipe), hole behind Vent Axia RHS pipe</p>

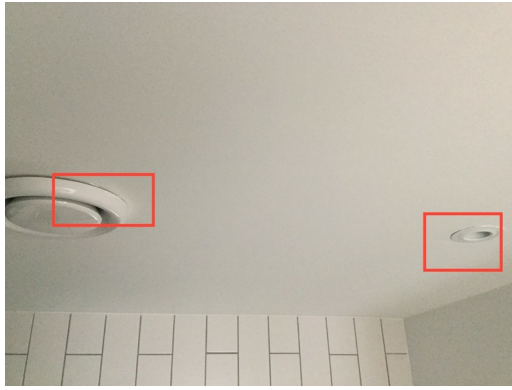
• Recessed down-lighters [0.20]

Poor finish around down-lighter and vent

poor finish

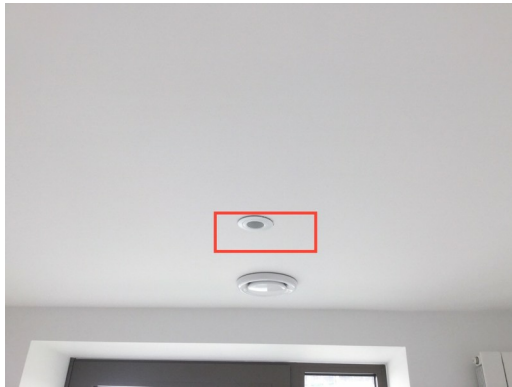
• Recessed down-lighters [0.31]

Not flush with ceiling

not flush with ceiling

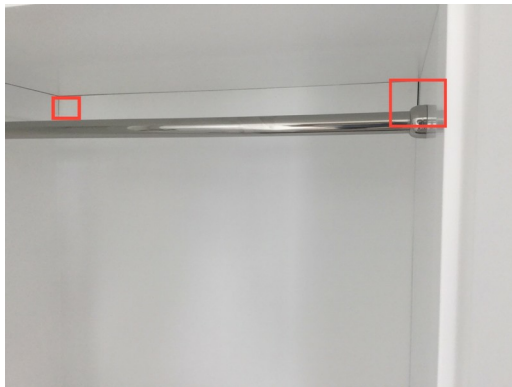
• Wardrobes [0.32]

Untidy mastic finish around frame

gaps

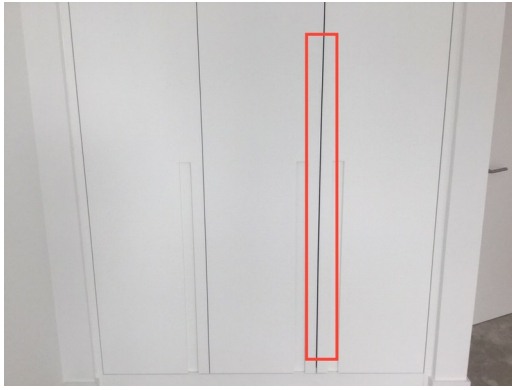
excessive gap

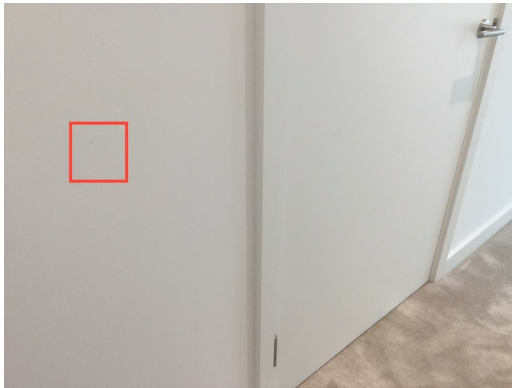
• Emulsioned walls  
[0.33]

Untidy finish, marked, scratched, shrinkage

indentation

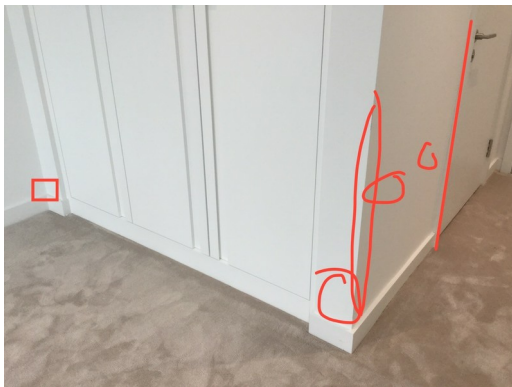
untidy finish, scratched, marked, shrinkage

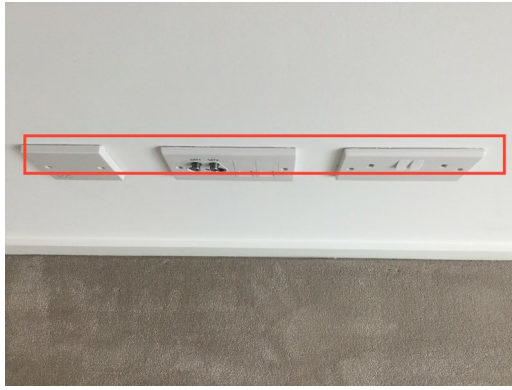
• Light  
switches/sockets  
[0.34]

Gaps around all sockets and far RHS switch

gaps

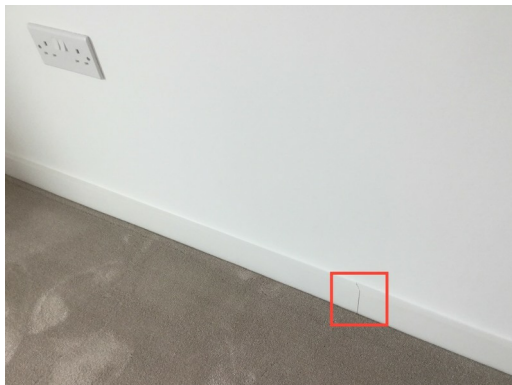
joint visible

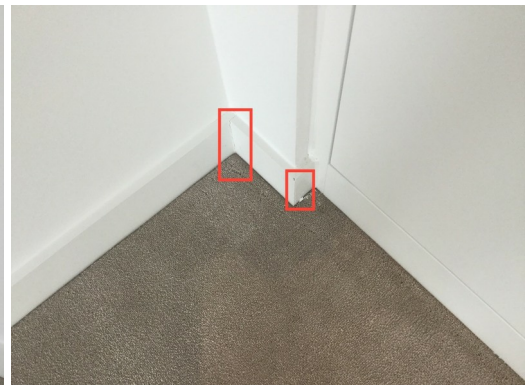
chip, shrinkage

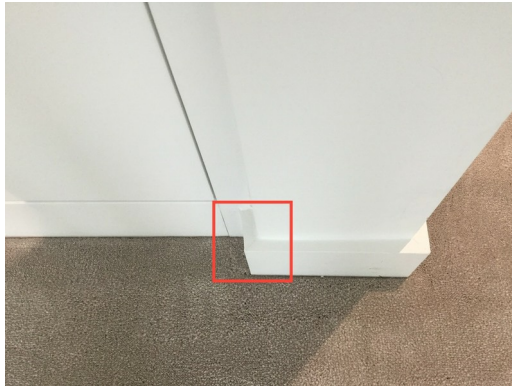
not square?

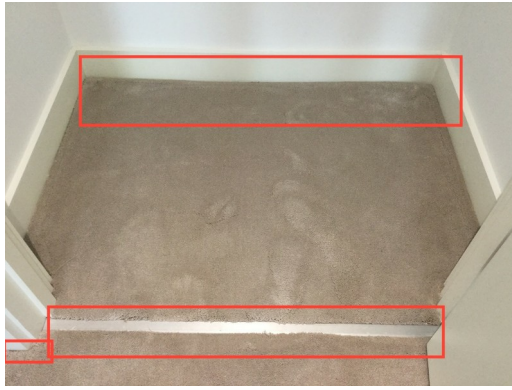
• Cupboard carpet [0.38]

Poorly fitted and trimmed

poorly trimmed and fitted

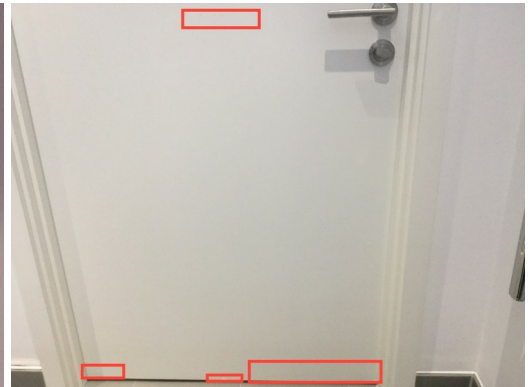
scratched, untidy finish

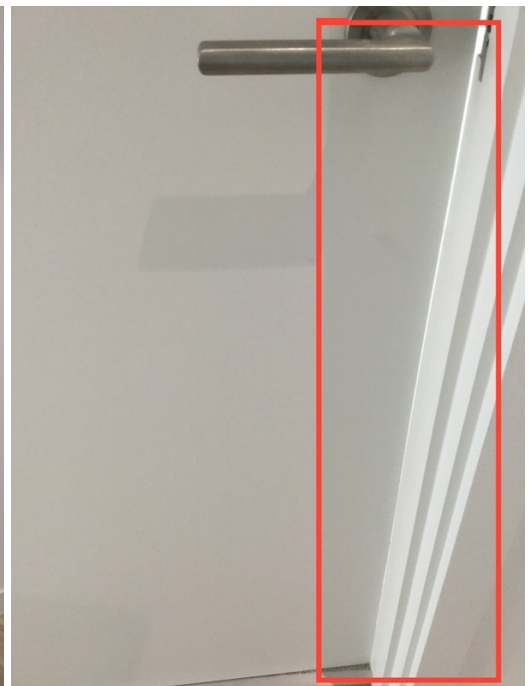
### • Door and doorframe [0.47]

Door/frame not square (unable to close)

Shrinkage along hinge side door frame

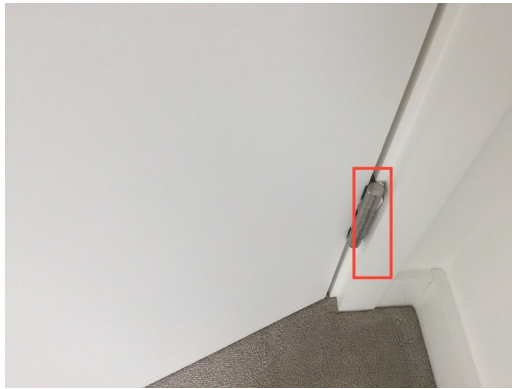
debris behind hinge

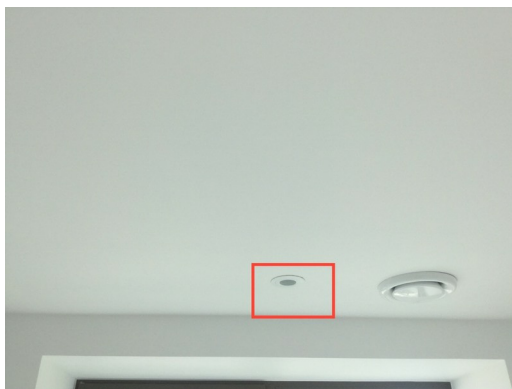
• Recessed down-lighters [0.48]

Untidy finish around RDL

untidy finish around DL

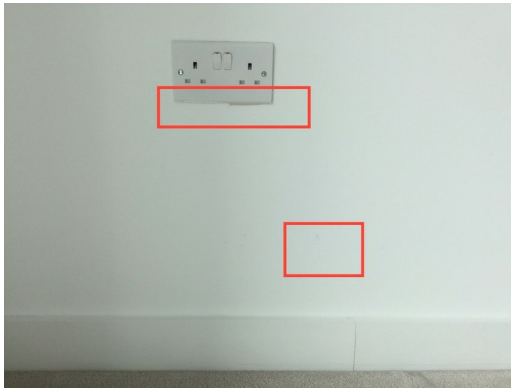
• Emulsioned wall  
[0.51]

LHS bulkhead above wardrobe not square.  
Untidy finish, indentations, shrinkage along doorframe right of light switch

poor finish, chipped, not level

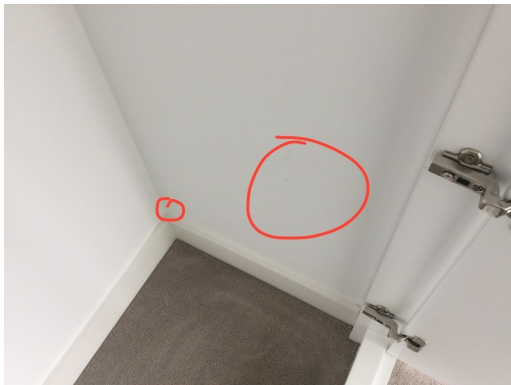
• Wardrobe [0.52]

Marked LHS around rail and RHS above skirting

marked untidy finish

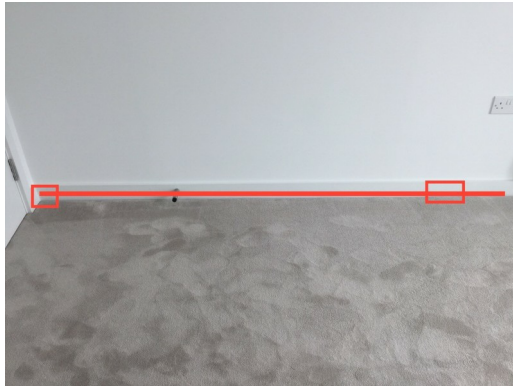
• Skirting boards  
[0.53]

Scratches, marks and chips

scratched, blemishes

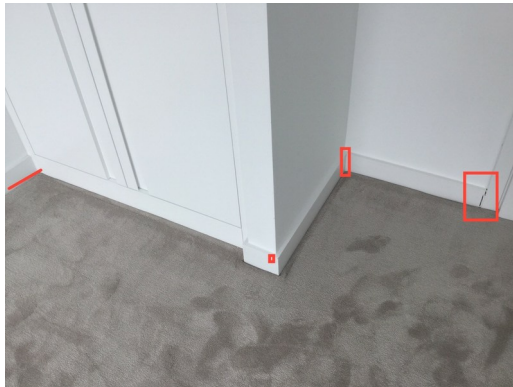
Scratched, chipped, gap

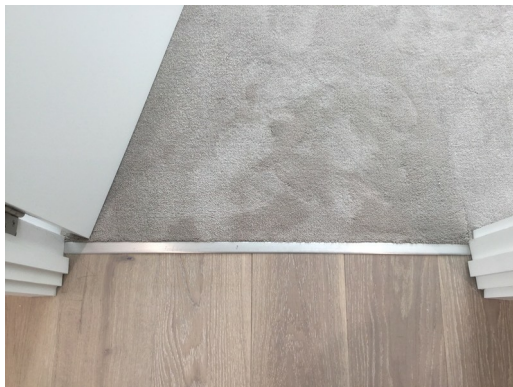
• Carpet [0.54]

Poorly trimmed

threshold scratched, poor trimming

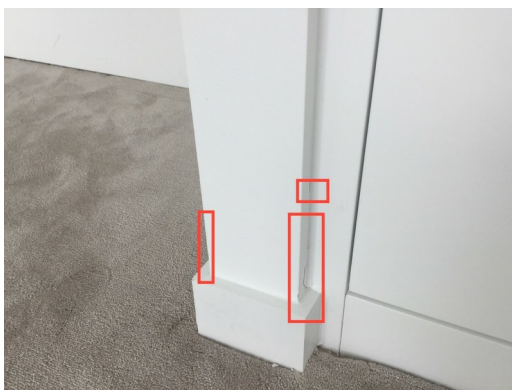
• Emulsioned walls [0.57]

Untidy finish, marked, gaps around sockets

poor finish, chipped

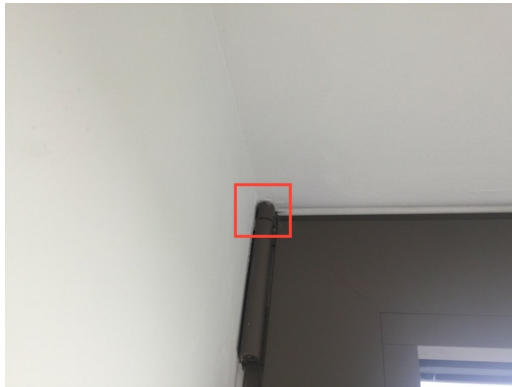
untidy finish

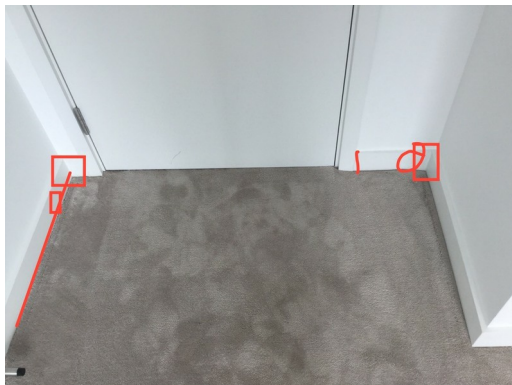
• Skirting boards  
[0.58]

shrinkage, marked

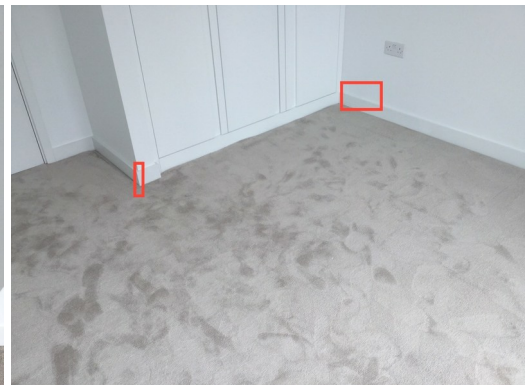
chipped, shrinkage

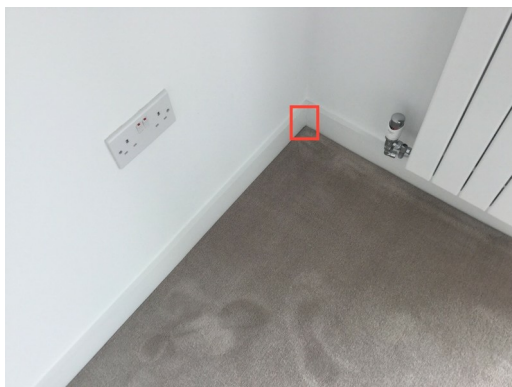
shrinkage

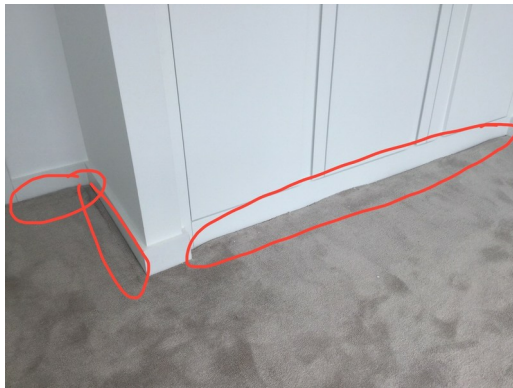
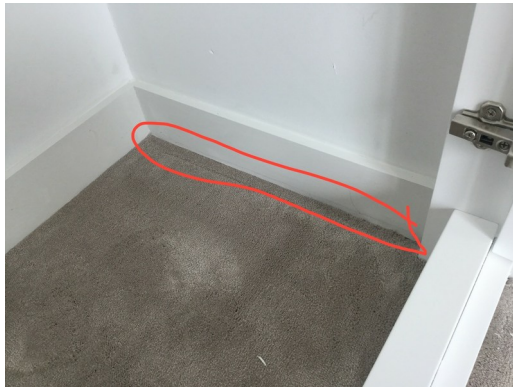
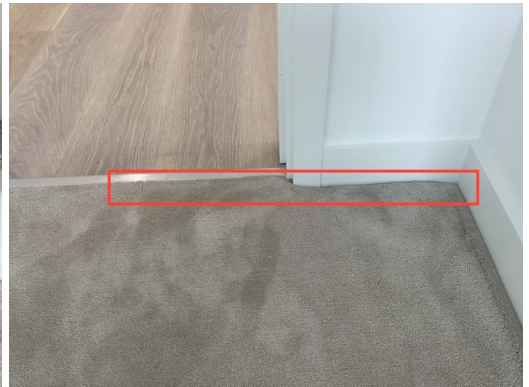
• Carpet [0.59]

Poorly fitted and trimmed

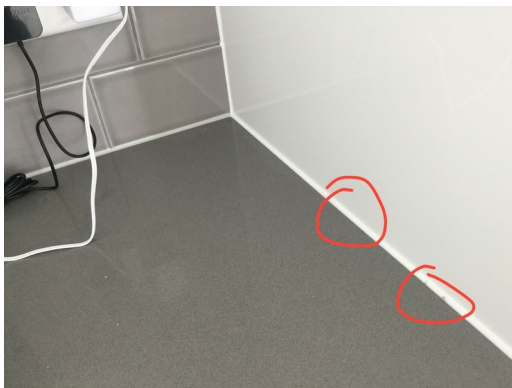
rough mastic finish

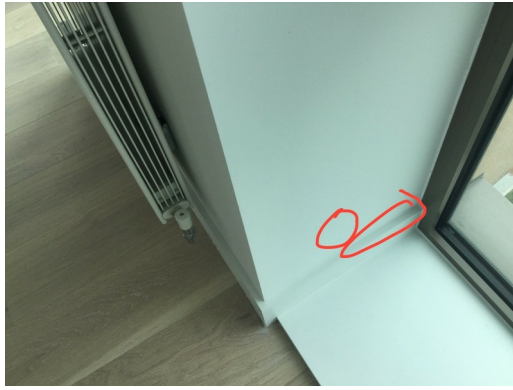
uneven finish

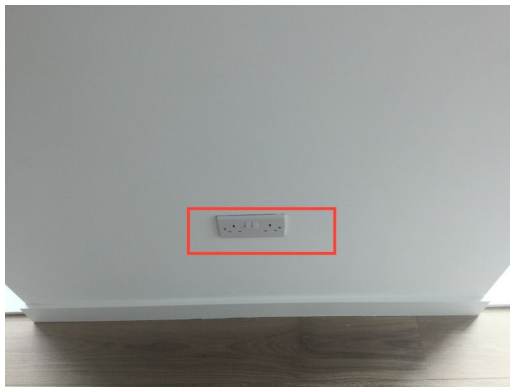
• **Double sockets**  
[0.76]

gaps

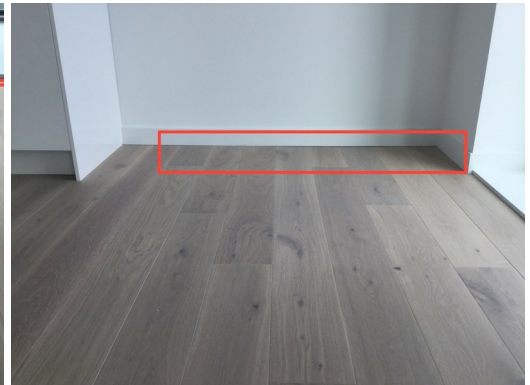
• **Hardwood flooring**  
[0.77]

uneven gaps

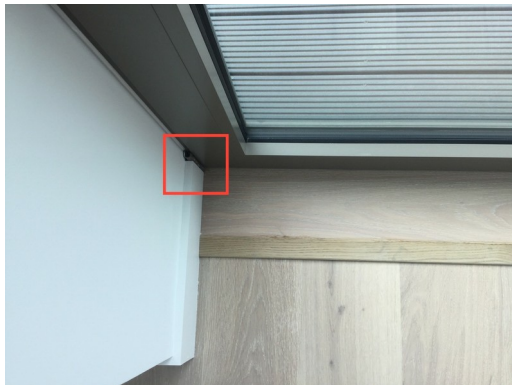
### • Balcony door and doorframe [0.78]

paint splashed on hinge

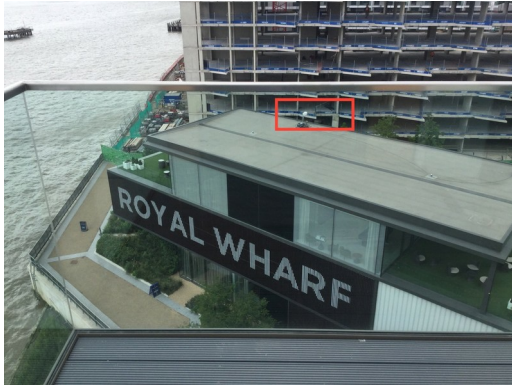
• Balustrade [0.80]

Exterior scratched
